REMEDIAL ACTION REPORT

**Pownal Tannery Superfund Site
Pownal, Vermont**

September 2005

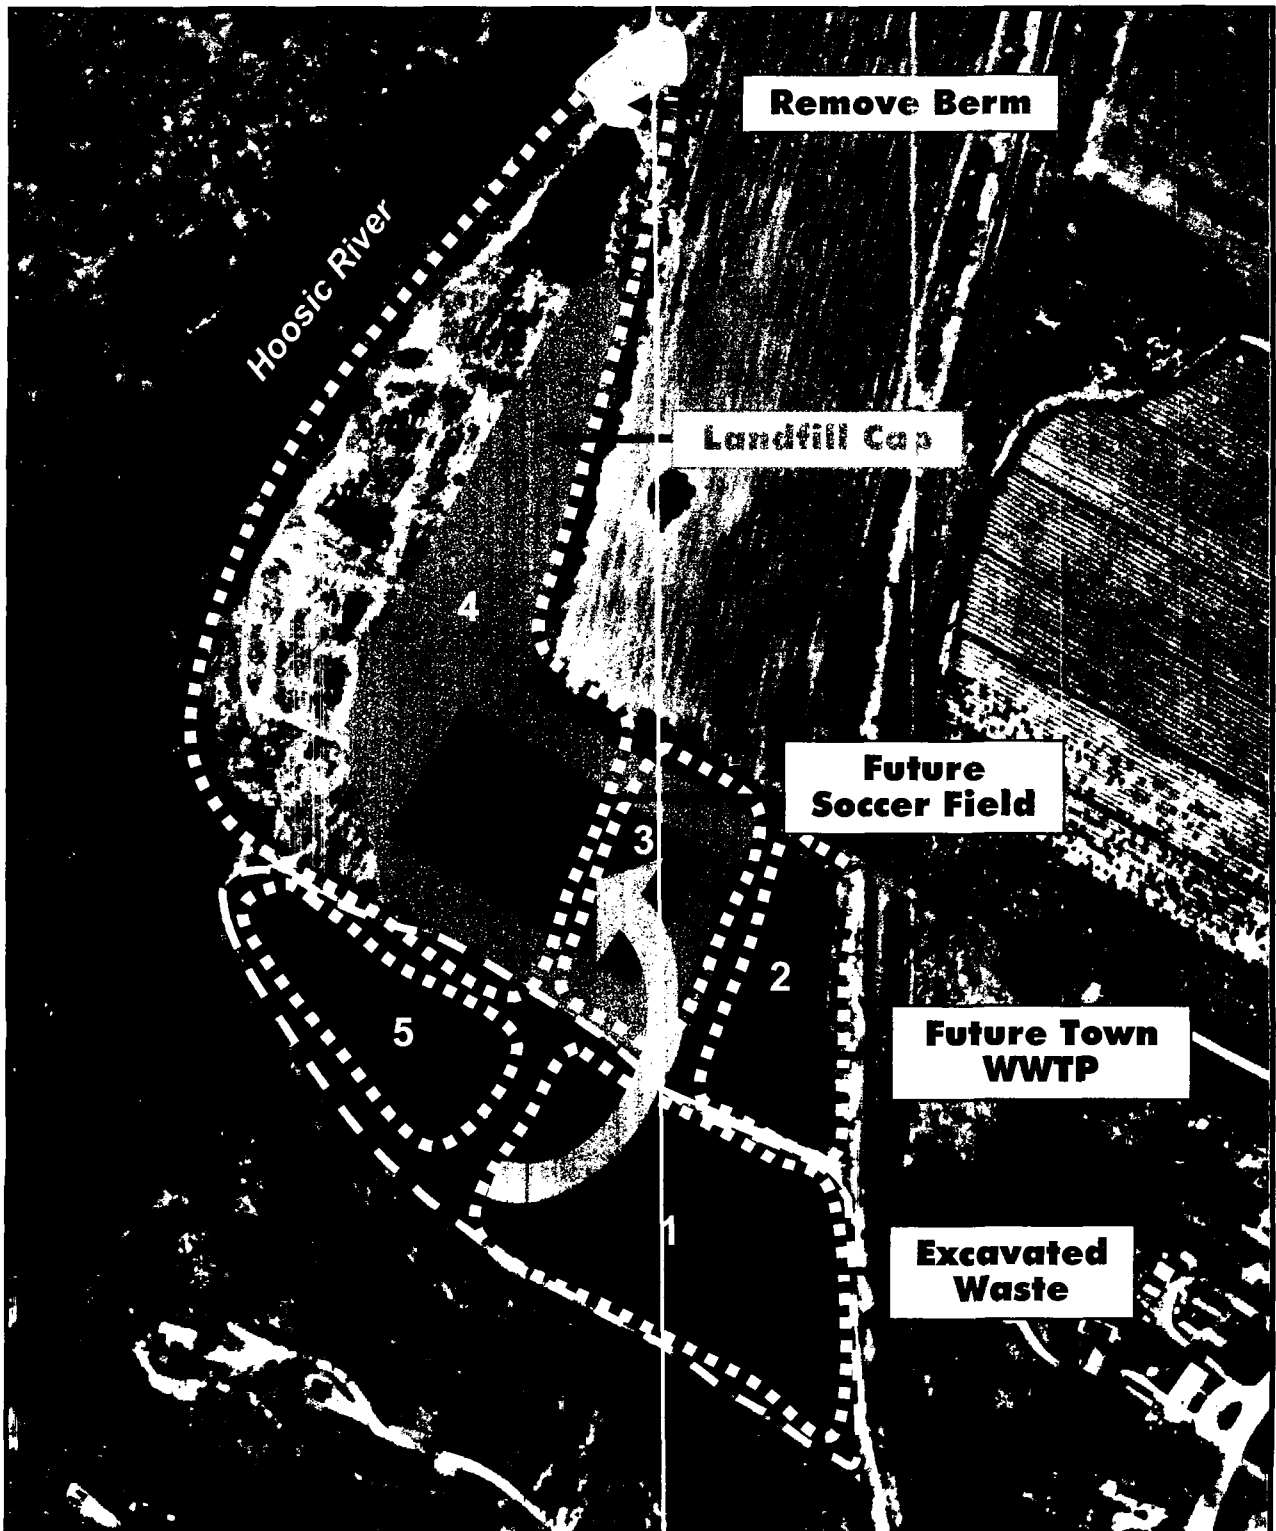
Figure 2
POWNAL LAGOON CLOSURE AND
REDEVELOPMENT

POWNAL TANNERY
 POWNAL, VERMONT

The lagoon area was addressed during an RI/FS, which began in the Spring of 1999, concurrent with the NTCRA, and was completed in July 2002. The RI/FS and human health risk assessment concluded that there is an unacceptable risk from exposure to sludge in lagoons 1, 3 and 5 (see Figure 2) and that a remedial measure was required. The Proposed Plan for the lagoon area was submitted for public comment on July 18, 2002. The ROD was completed in September of 2002. The Proposed Plan called for excavation of saturated and unsaturated contaminated soil and sludge in lagoons 1 and 5 and consolidation of these materials over lagoon 3 and in the southeast corner of lagoon 4. To reduce the potential human-health risks associated with direct contact with the contaminated material, the remedy included covering the soil and sludge with a low permeable landfill cap. The consolidated wastes were graded and storm water controls installed to minimize groundwater infiltration into the wastes. This cap was designed to resist future flooding events and to protect future users of this property from direct contact with the sludge material. Maintenance of the landfill cap is being performed by the VTDEC and is required for at least 30 years.

The approximate extent of the in-place cap is shown in Figure 2. The stabilized sludge that was transported to lagoons 3 and 4 was compacted to 90 percent of the maximum dry density determined in accordance with the standard Proctor compaction test. Lagoons 3 and 4 were not stabilized, as they did not need to be excavated and transported. No chemical testing of excavated sludge was conducted since all sludge was moved to the landfill and capped. A low-permeability cap was constructed over the excavated sludge and soil to limit exposure to the contaminated material, to mitigate infiltration of contaminants to the groundwater and to prevent erosion. The landfill cap has a five percent slope on the barrier and drainage layer and a two percent slope on its surface. The cap has the following configuration:
